INFORMATION FOR HISTORIC BUILDING OWNERS

Repointing Ashlar Masonry

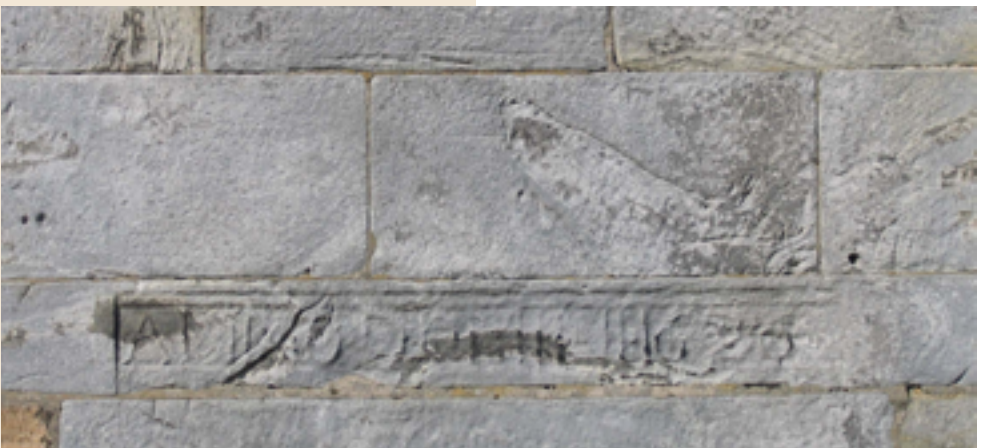
Fig. 1 Example of ashlar masonry with letters shown in relief.

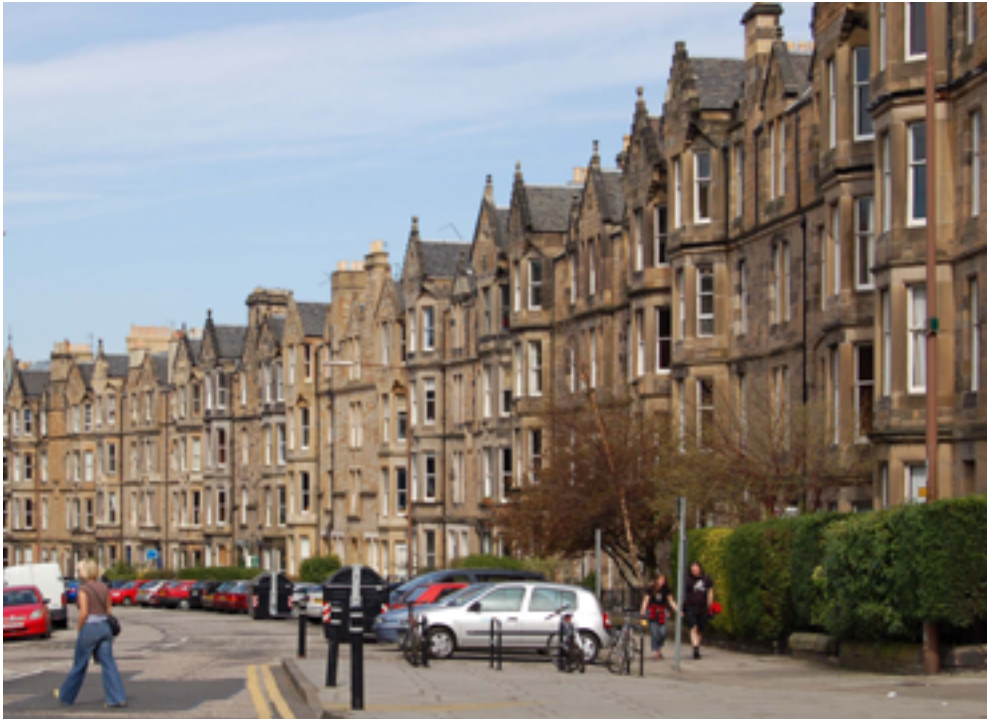
Fig. 2 Ashlar buildings became common in Scottish towns and cities during the 19th century.

Although well-established by this pedigree, it was only from the mid-19th century when stone quarrying and working techniques became more mechanised and economic that it became possible to build domestic dwellings that incorporated ashlar façades (Fig. 2). Found equally on city tenements, villas, and rural farmhouses, this approach to building lasted into the early decades of the 20th century.

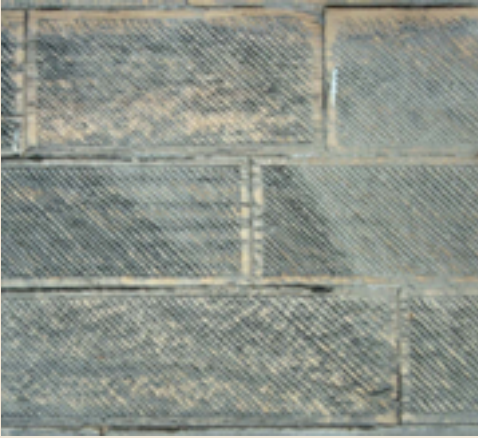
Fig. 3 Fine joints on a tooled ashlar façade.

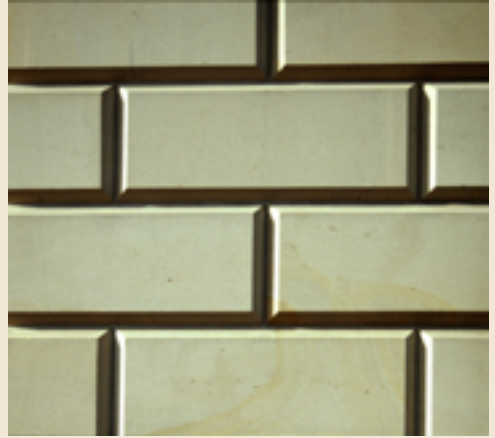
Fig. 4 Chamfered ashlar masonry.

The surface finish of buildings with ashlar walling differs from that of rubble walling. The precise shape and size of ashlar blocks results in the formation of very fine joints. Unlike those in rubble walling that typically exceed 10mm in width, the joints and beds in ashlar masonry generally only amount to a maximum of a few millimetres as a result of the accuracy in block cutting in Georgian times (Fig. 3). During this period, the exposed face of the ashlar block may also have been adorned with a chamfer, which created the illusion of V-shaped joints when the blocks were put together (Fig. 4), or tooled to produce decorative patterns.

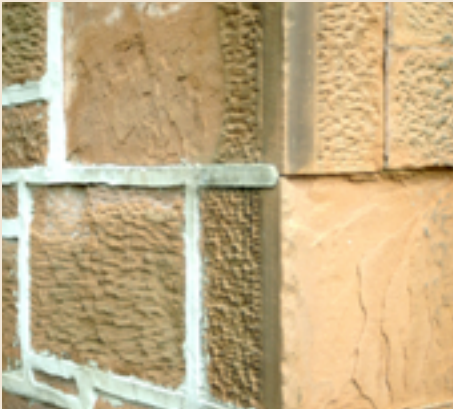
Fig. 5 Projecting cement pointing causing stone deterioration (© I. Maxwell).

of a building is compromised, there can be a number of negative consequences, these include masonry deterioration, internal damp and rotting timbers. The most common cause of such problems is the use of impermeable mortars and/or coatings, the most widespread of which is cement (Figs. 5 and 6).

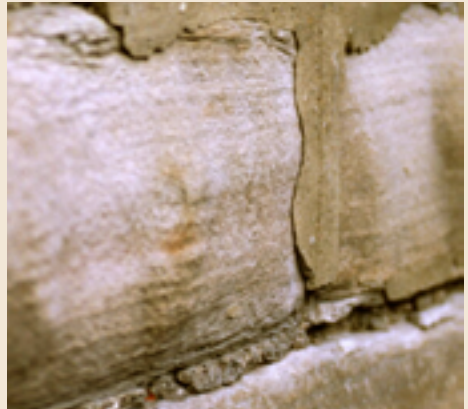
Fig. 6 Cement coating smeared on stone. The fine original joints can be seen where the superficial cement pointing has failed and detached causing considerable damage to the masonry.

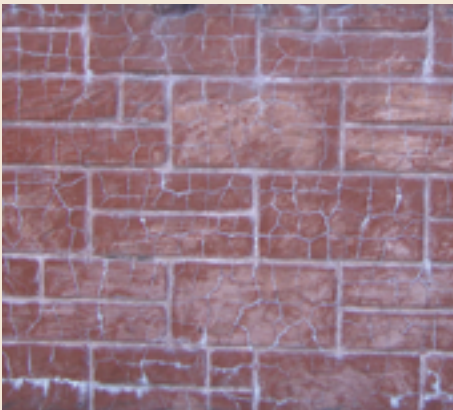
Fig. 7 Cement coating over ashlar showing crazed cracking over the surface.

Cement is a hard, impermeable material that is inherently incompatible with porous stone masonry. Although the impermeable nature of the material should, in theory, keep water out of a building, the fine hairline cracks that form as it sets act as capillaries, drawing moisture into the building (Fig. 7). The inability of the material to ‘breathe’ prevents this moisture from escaping, causing it to build-up and, over time, impose stresses on the masonry that can lead to accelerated stone deterioration.

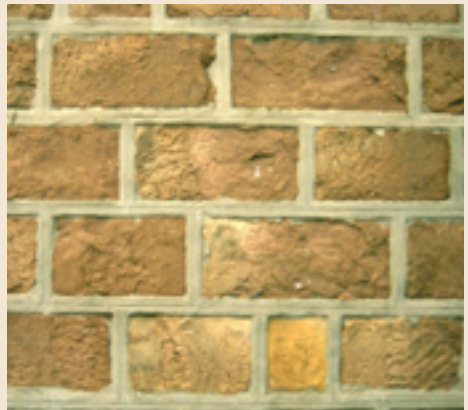
Fig. 8 Superficial over-pointing of stone with cement mortar.

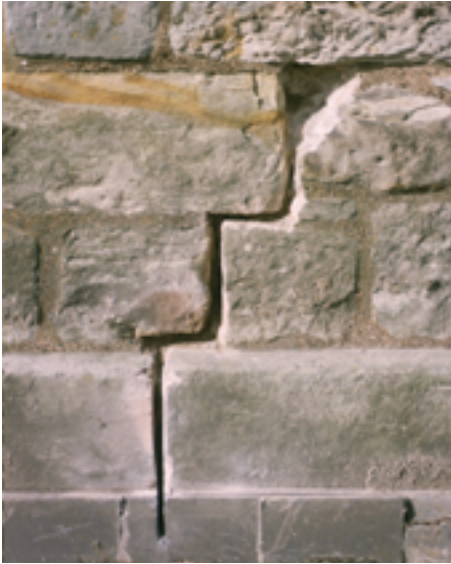
Fig. 9 Damage caused through the use of inappropriate power tools for removal of pointing mortar (© I. Maxwell).

material out by means of a handheld hacksaw blade inserted into the joint and gently pulled forward. It is generally not advisable to use power tools to cut out the decayed or loose mortar from the fine joints due to the risk of damage to the stone (Fig. 9), although, when used by a highly skilled operative good results can be achieved. Traditional hand tools such as chisels can equally cause damage as these simply do not provide the precision required for the fine joints in ashlar masonry.

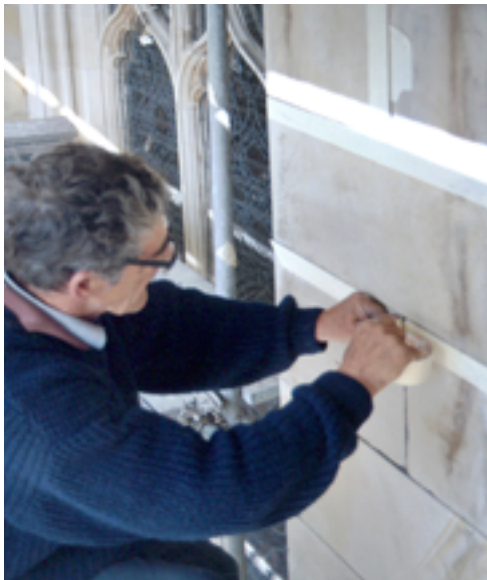
Fig. 10 Taping around joints to prevent staining and damage of stone (© I. Maxwell).

Open joints should be flushed out with a low pressure jet of clean water to remove all traces of dust and debris that might prevent the new mortar from bonding with the stone. Additionally, damping down the stone before application of the mortar prevents the mortar from drying too quickly. Before applying the mortar, it is advisable to tape over the stones' arrises (edges) with heavy duty sticky-

backed tape, or similar material, to protect the adjacent stones against staining and mechanical damage during repointing (Fig. 10). Care should be exercised in the choice of tape as some brands can leave an adhesive residue on the stone's surface that can be difficult to remove (Fig. 11). Before work starts, the chosen tape should be tested in a discrete location to determine if this will happen.

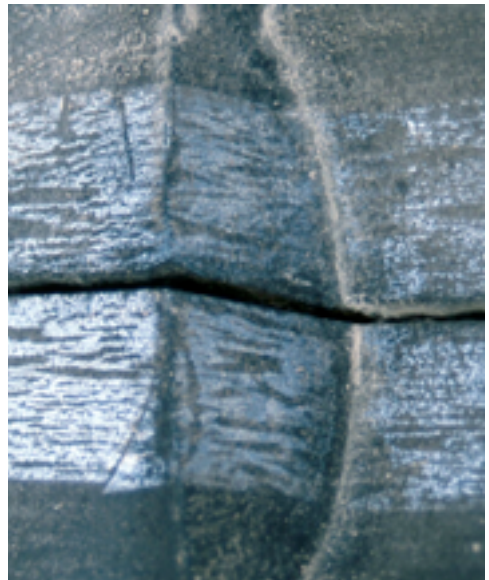
Fig. 11 Residue left on stone surface from sticky tape (© I. Maxwell).

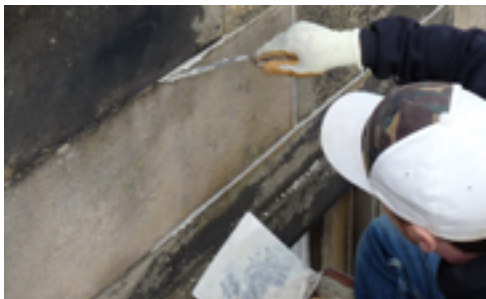
Fig. 12 Repointing ashlar using a fine pointing key.

Lime mortar can be inserted into the narrow ashlar joints in three ways – by using a suitably dimensioned thin tool that easily fits into the joints (Fig. 12), such as a pointing key or steel blade, by pressing in the mortar from the face of the stone, or by careful injection using a proprietary tool. Each technique
